# Urgent measures to repair flood damage to the L73 road: Slope stabilisation with TITAN micropiles

**Project:** Urgent measures to repair flood damage on L73 road between Schuld and Insul

#### Project Report | Anchored shotcrete facing with TITAN micropiles for slope stabilisation

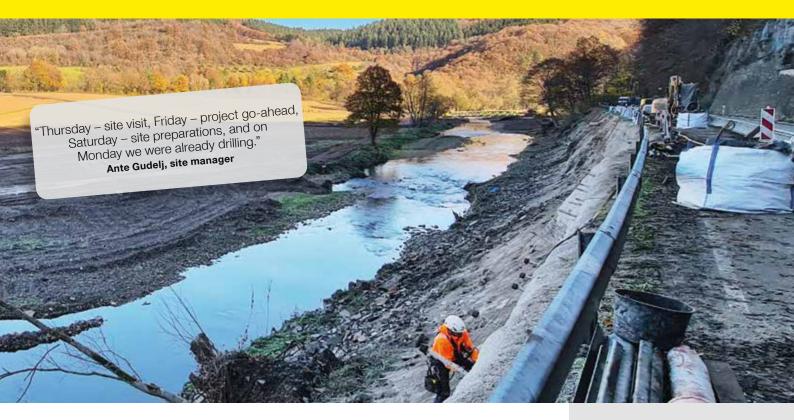
The Ahr Valley in northern Rhineland Palatinate is one of the Rhine's smallest side valleys. On 14 July 2021, following hours of heavy rainfall, large parts of the towns and villages along the River Ahr were devastated by horrific flooding. The L73 main road between Schuld and Insul was affected by a slope failure on the river side.

The natural stone wall built to stabilise the slope alongside the road was completely destroyed by the raging floodwaters over a length of about 400 m. Further slope failures could not be ruled out, and so urgent action was called for in order to keep at least one lane of the road open. Very cramped working conditions – the L73 has very narrow lanes and no shoulder – plus the risk of slippage at the top of the slope were other complications that had to be considered.

Urgent work was required to secure the slope at risk of failure and therefore TITAN micropiles supplied by Friedr. Ischebeck GmbH were chosen to anchor a shotcrete facing. Almost 1000 TITAN 40/16 micropiles, 6 m and 9 m long (2970 m in total), were installed alternately on a 1.5 x 1.5 m grid. Small, lightweight plant was used to carry out the work. Drilling rods had to be extended manually by personnel secured by ropes. Nevertheless, a total of about 150 m was drilled every day. It was possible to use the same excavator boom for both installing the TITAN micropiles and spraying the shotcrete.

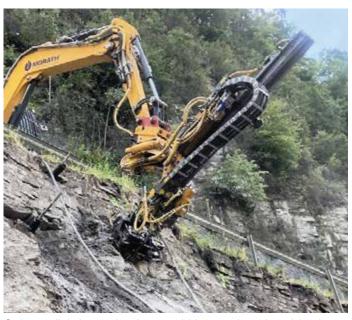
Only small, lightweight plant could be used, and could only work from above.
